July 2014

# Repeaters #4

Bill Murray

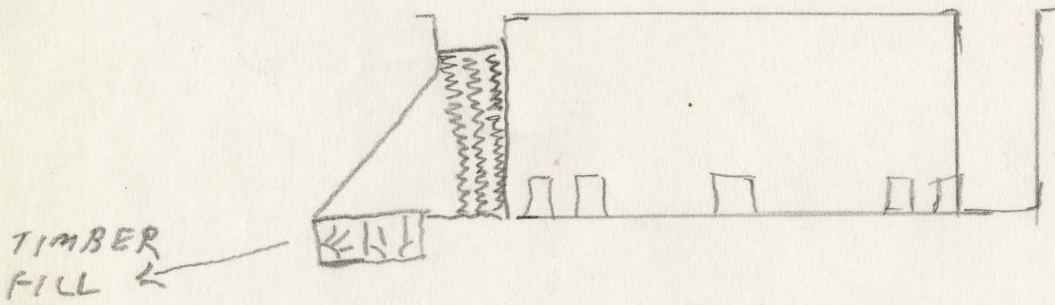
The only trouble experienced with repeating was caused by back ends lashing against the side of repeaters. This violent lash resulted in a "pig tail" at the extreme end of the section, which was pulled off in the receiving guide of the next stand, and block the guide causing the next piece to fail.

By good speed control, this would be less likely to occur, but speed controlling is generally not good during a mill start up.

These chains take the back end lash and prevent the formation of the "pig tail".

To overcome the "pig-tailing" a chain curtain has been hung at each repeater on the delivery side. The curtain is three rows deep of about 3/8" to 1/2" diameter short links set at about 1.1/4" centres and the lower ends lying on the repeater floor.

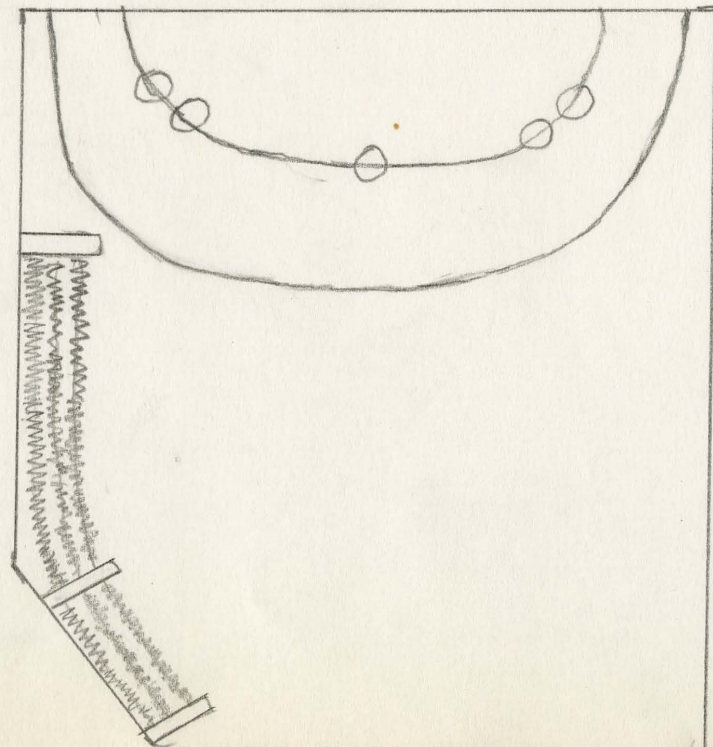
Incidentally, the repeater trap on the delivery side does not function as intended and, particularly at high speeds, is a hindrance rather than a help.

When these recesses were filled in with timber the mill had less trouble.
