# Analysis of the Self-Contained Breathing Apparatus Face Piece For Fire Service Use

**Major Qualifying Project Report**

**WORCESTER POLYTECHNIC INSTITUTE**

**Date: April 25th, 2012**

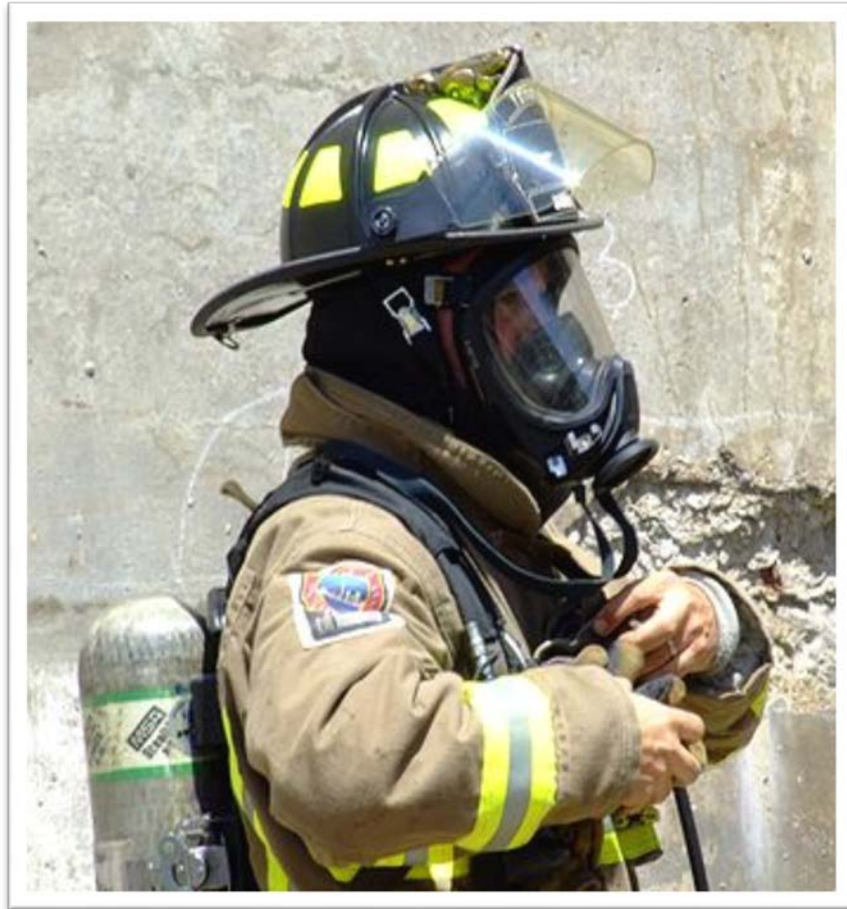
**Figure 1: SCBA**

SCBA devices are composed of three major components: a high pressure cylinder, a pressure regulator and a face mask that in combination provides firefighters with a remote breathing supply during a fire. These devices are one of the most essential personal protective equipment available to fire fighters. It allows them to enter hazardous environments and perform interior operations that range from search and rescue, ventilation and offensive fire attacks. It protects them from smoke, irritants attacking sensory nerves and hypoxic effects on vital organs. Smoke and irritants can become extremely painful and debilitating leading to problematic rescue operations. An optical density of 0.2/m for irritant smoke can decrease walking speeds from 1.2m/s to 0.3m/s.

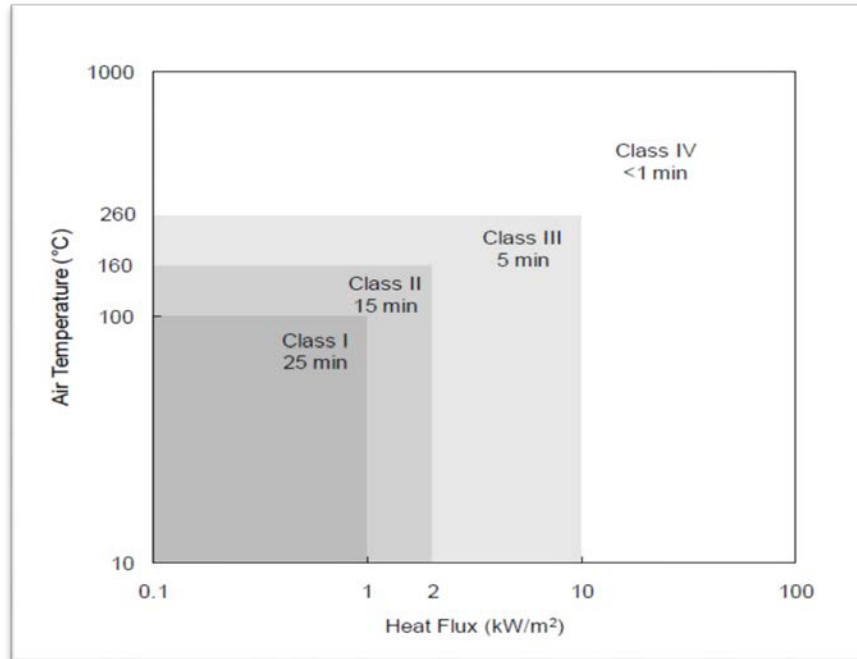
**Figure 2: Fire Classifications**

In recent years there have been seven firefighter fatalities as a result of the thermal degradation of SCBA's. The victims were found with their masks damaged but still in place which suggests that there may have been an increase in thermal energy and the firefighters were unable to escape in time [7]. This is one of the setbacks of the personal protective gear, firefighters may be unaware of the extreme dangers they are in because they are unable to get a real sense of the amount of thermal energy present. Firefighter bunker gear is designed to withstand temperatures around 250 degrees Celsius however the closer you are to the ceiling the higher the temperatures are due to hot gases and smoke rising which forms what we call the upper gas layer where temperatures can range from 100-300 degrees Celsius and heat fluxes between 5-12 kW/m<sup>2</sup> at pre flashover [7]. While the thermal environment varies depending on fuel load, ventilation and construction layout Donnelly classified firefighting environments into four classes that can be used to establish performance requirements for protective equipment standards as shown in Figure 2 [4].

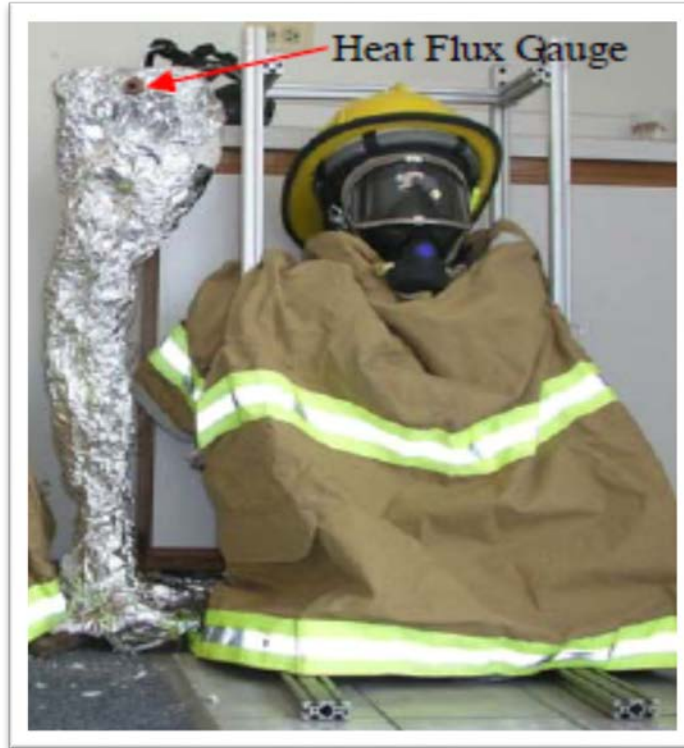
**Figure 3: NIST Experimental Set Up**

As seen in Figure 3, the facepiece was mounted onto a polyurethane test headform and secured to an aluminum test stand that was covered with fire fighter protective gear. A Schmidt-Boetler water cooled heat flux gauge protected by ceramic fiber insulation and aluminum foil placed 1 meter above the ground facing the same direction as the face piece was used to record the heat flux during the experiment. In addition, k-type thermocouples were placed in various areas in the room to measure temperature layers all around the face piece and five thermocouples were secured around the face piece to measure air and surface temperatures. For more information on the experimental set up and conditions see [5].

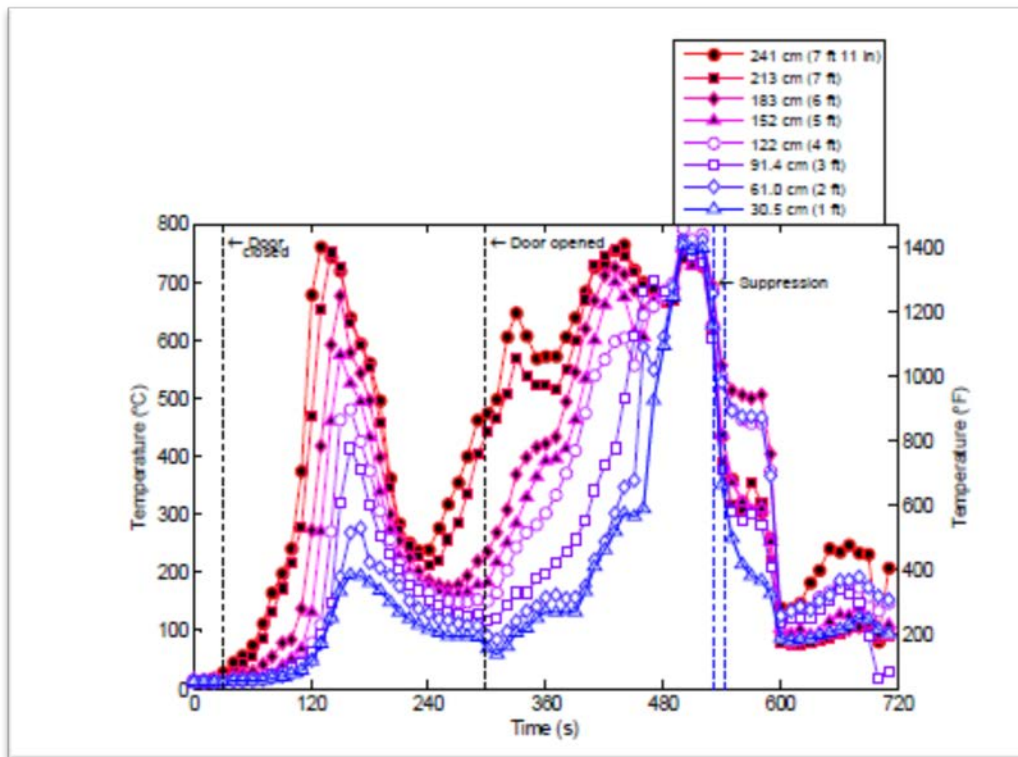
Figure 4: NIST Temperature Profiles

Figure 4 shows the temperature profiles from the experiment. Notice how the fire peaks twice, first when the fire was created and the second time when the door was opened. Note that facepiece was not exposed to any heat until the door was opened. It was found that the outside air temperature was always cooler than the temperature of the

surface of the facepiece. This is strong evidence suggesting that radiation was the key form of heat transfer. If convection was the main form of heat transfer the surrounding air would at least be the same temperature as the surface of the facepiece. Furthermore no flames from the door ever came in contact with the facepiece yet the heat flux gauge measured  $40\text{kW}/\text{m}^2$  and  $50\text{kW}/\text{m}^2$  for about a minute. After the experiment the face piece showed clear signs of failure with extensive bubbling of the polycarbonate lens as seen in Figure 5. Due to the findings of previous studies the major qualifying project will investigate the effect of radiation on polycarbonate and polyethersulfone.

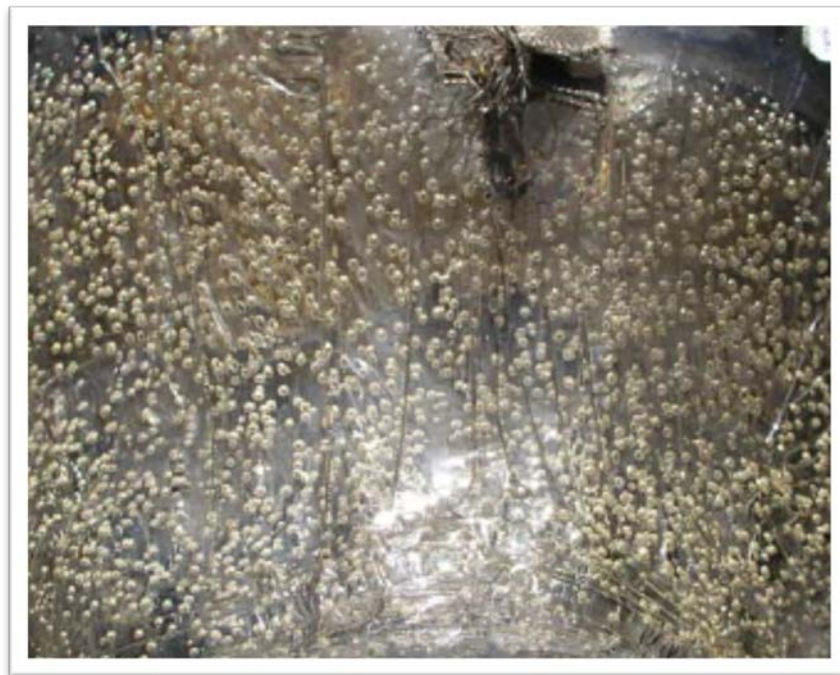
**Figure 5: Thermal Degradation**

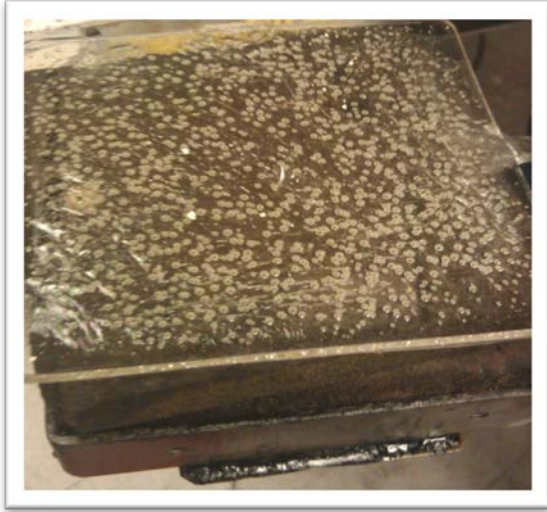
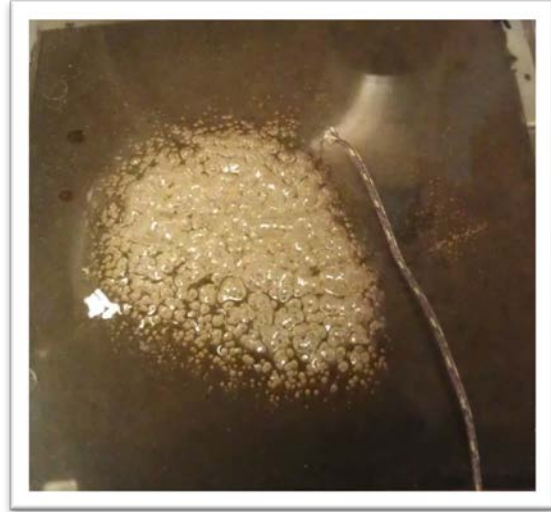
Bubbling such as in Figures 8 & 9 was considered failure. It should be noted that deformation occurred within 10 seconds of the first sign of bubbles on the samples. Note Figures 8 & 9 illustrates failure at 10kW/m<sup>2</sup>. The formation of bubbles on the center of the polyethersulfone is attributed to the slight concave down shape, in addition to the heating coil located above the sample.

Figure 8: Polycarbonate Failure

Figure 9: Polyethersulfone Failure

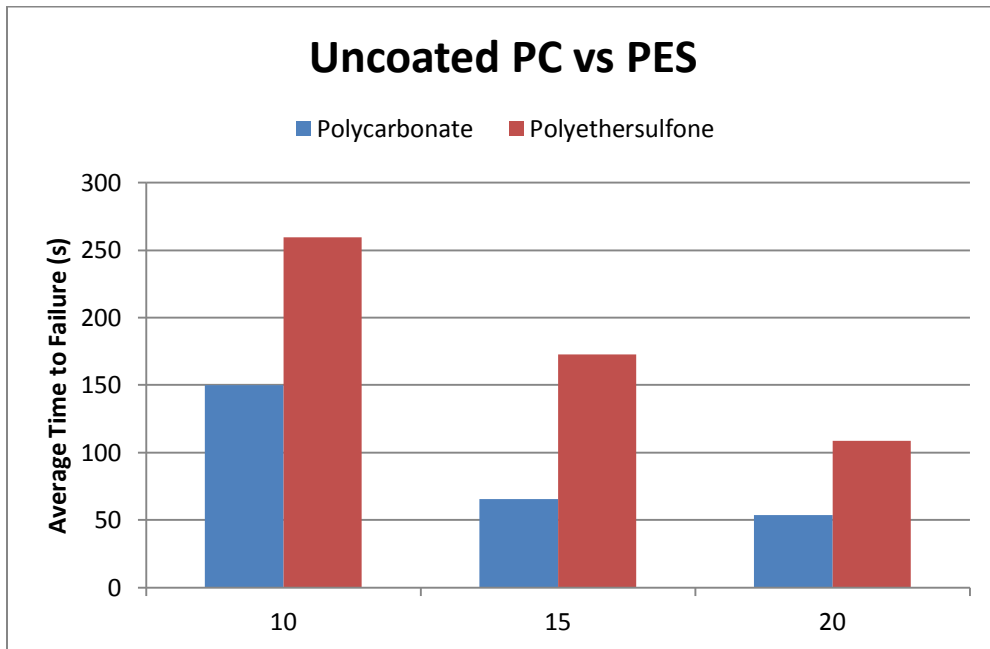
The uncoated samples portrayed the expected behaviors that correspond to the material properties of polycarbonate and polyethersulfone. For the low heat flux polycarbonate failed on average of 11°F higher than the polyethersulfone however even though the temperature of failure was lower the average time to failure was 110 seconds greater for the polyethersulfone. For the medium heat flux the polyethersulfone failed on average of 28°F higher than the polycarbonate and the time to failure was greater by 107 seconds. For the high heat flux the temperature of failure for polyethersulfone was greater on average by 51°F and the time to failure on average was greater by 55 seconds. Figure 12 & 13 compares the average temperature and time of failure for uncoated polycarbonate and uncoated polyethersulfone.

Figure 10: Uncoated PC vs PES

Figure 11: Uncoated PC vs PES

The results suggest that polyethersulfone does indeed possess some superior material properties when compared to polycarbonate but when both materials are coated their intrinsic properties are no longer a measure of how the materials perform when exposed to fire environments. On average the uncoated polyethersulfone fails at a higher time and temperature than the uncoated polycarbonate. The application of coatings to the polycarbonate plaques were able to increase the average failure temperatures by 16°F for low heat flux, 34°F for medium heat flux and 70°F for high heat flux. In comparison the application of coatings for polyethersulfone did not show much change for a low and high heat flux but for the medium heat flux it was able to increase the temperature by 19°F. This suggests that the coatings have more of an impact for the polycarbonate because there is still a limit to the amount of protection which the coatings offer.

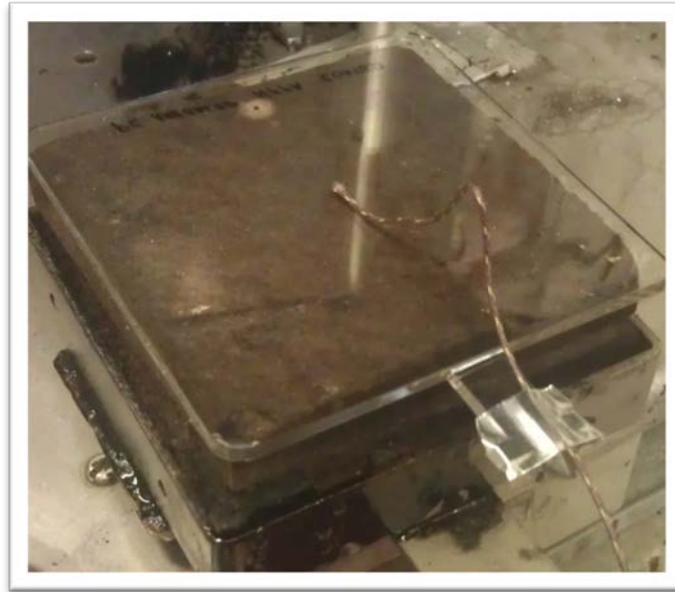
Figure 17: Thermocouple Attached to Center of Plaque

Each test specimen was prepared by attaching thermocouples to the center plane surface of the material using aluminum tape (See Appendix A). The thermocouple was shaped and manipulated so that the bead sat in the correct position. This setup procedure was modeled off of the procedure used in the experiments carried out and reported in NIST Technical Note 1724.
