IMPROVEMENTS TO THE WPI POWERPLANT COAL BIN

Major Qualifying Project

March 7, 2014

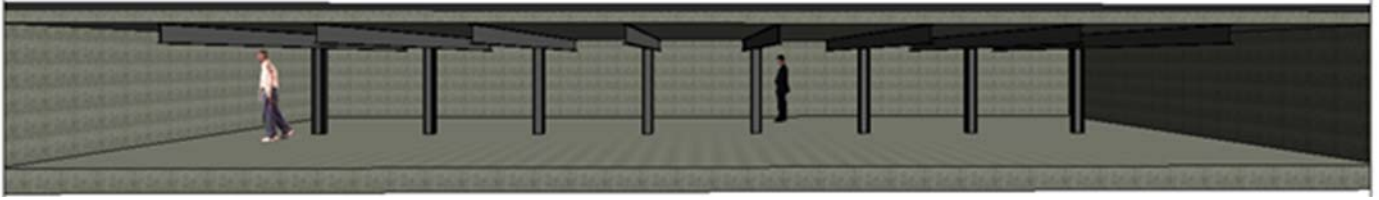
Figure 17: North Elevation

This option allows for a smaller steel member because it utilizes the compressive strength of the concrete. This is achieved with the use of steel shear studs welded to the beams before the concrete is placed. Again this option is broken down into a column and no column design. A summary of the full composite member size required can be seen in Table 4. Renderings of this design option can be seen in Figure 15 to Figure 20.

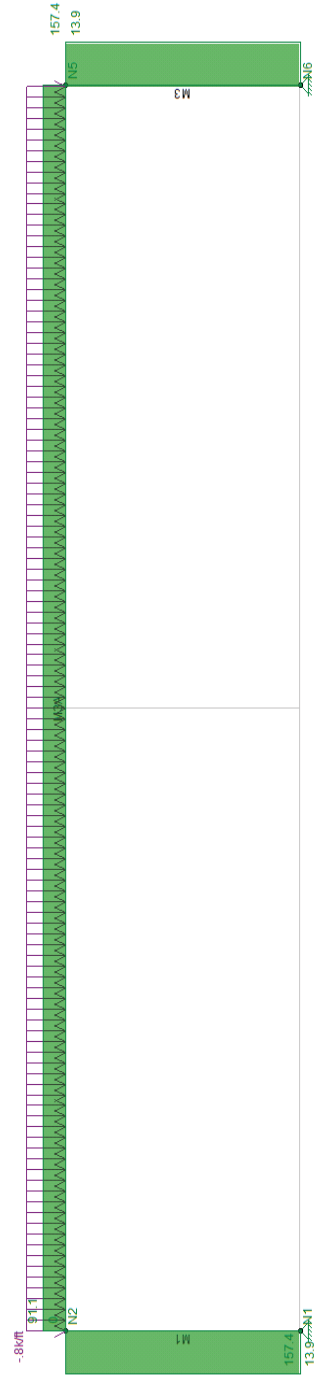
North - South Loads - No Columns

used for design option 1 & 2
