Investigation of Fatigue Crack Initiation in Ti-6Al-4V During Tensile-Tensile Fatigue

Ivanova, Svetlana G. , Biederman, Ronald R. , Sisson, Richard D. (2002). Investigation of Fatigue Crack Initiation in Ti-6Al-4V During Tensile-Tensile Fatigue. *Journal of Materials Engineering and Performance*, 11(2), 226-231.
Retrieved from: <https://digitalcommons.wpi.edu/mechanicalengineering-pubs/15>

Svetlana G. Ivanova, Ronald R. Biederman, and Richard D. Sisson Jr.

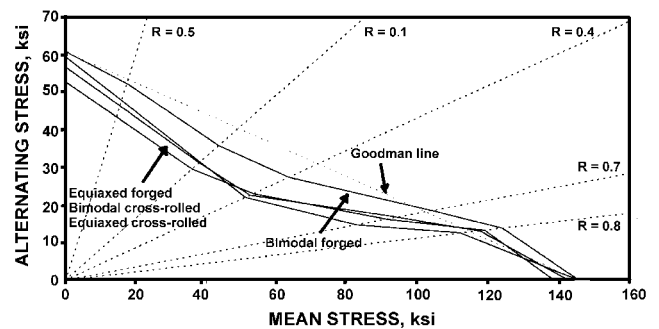
Fig. 2 Constant life diagrams at 10^7 cycles^[11]

Microstructures investigated in this work were obtained from two different initial materials: cross-rolled bar and forged bar. Both of them were heat-treated to yield two types of microstructure: equiaxed and bimodal. All four resulting microstructures are presented in Fig. 1. The results of chemical analysis are presented in Table 1. Table 2 gives information on heat treatments and quantitative analysis of microstructures, and Fig. 2 presents corresponding constant fatigue life diagrams.^[12]

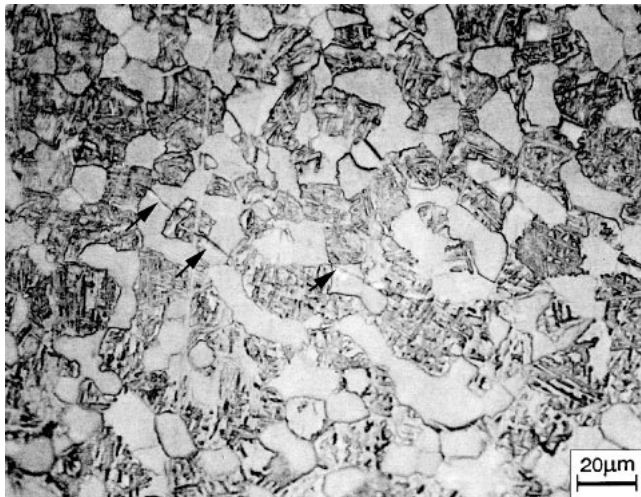
Fig. 9 Replicas of crack initiation site for material with bimodal forged microstructure ($R = 0.1$, $\sigma_{\max} = 620$ MPa, $n = 1,990,000$ cycles)

The bimodal forged microstructure showed very high resistance to crack initiation. The crack was first detected only at 1,950,000 cycles, again in the alpha grain. As seen on Fig. 9 after 1,990,000 cycles, two more alpha grains became cracked while the beta-transformed phase surrounding them was still crack-free.
